ADDITIONAL INFORMATION FOR FINAL CLOSEOUT REPORTS FOR BUILDINGS 910 AND 993 CLOSURE PROJECTS - FEG-005-04

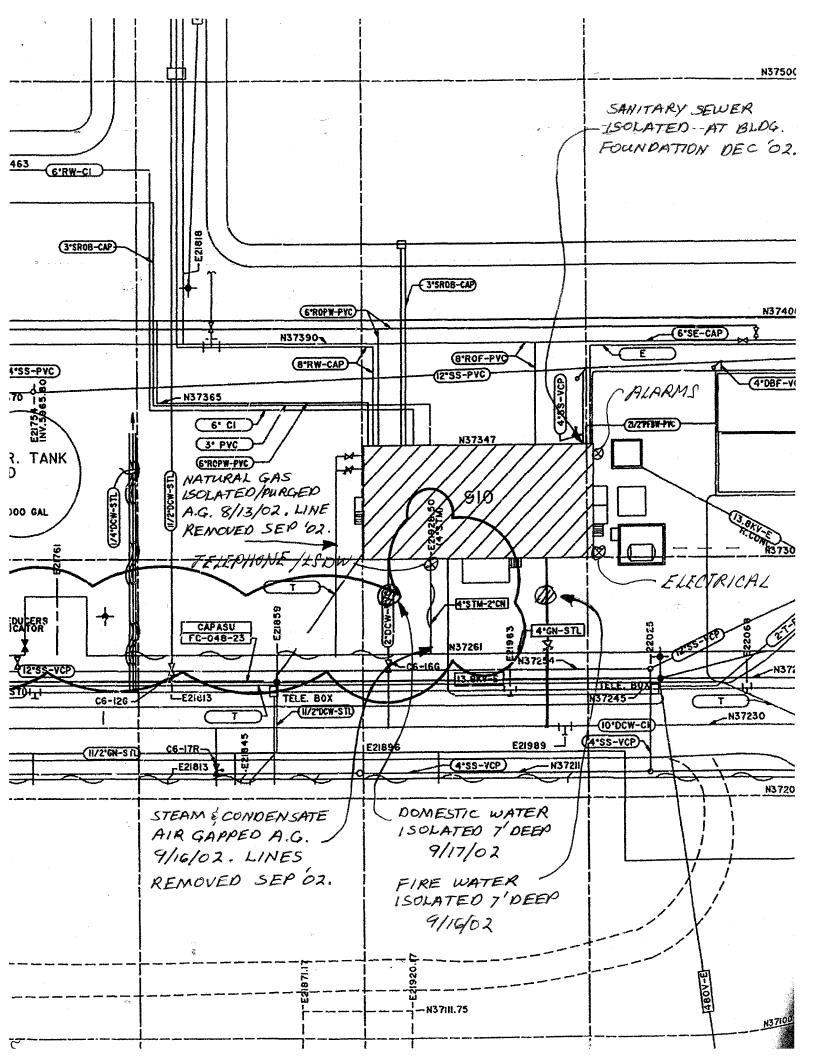
Attachment 1

Building 910 Map - Fire Protection Line, Domestic Water Line, Sanitary Sewer Line, Natural Gas Line, Electrical Line, and Telephone/LSDW Line

- Sanitary sewer line entered Building 910 from the northeast corner of the building. This line was flushed with water, isolated at the building foundation, and grouted. The remaining line is approximately 8' deep.

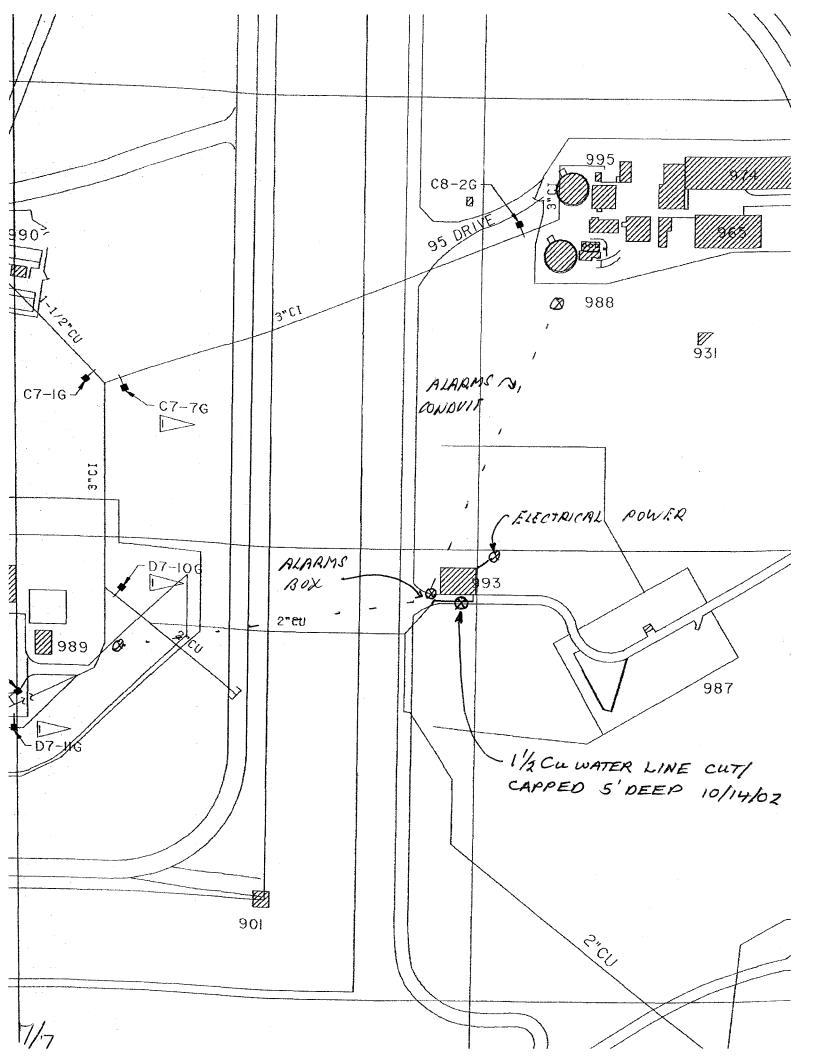
Attachment 2

Building 993 Map - Location of Domestic Water Line, Electrical Line, Telephone Line and Alarm System Lines
